Oxley Creek Condition Assessment

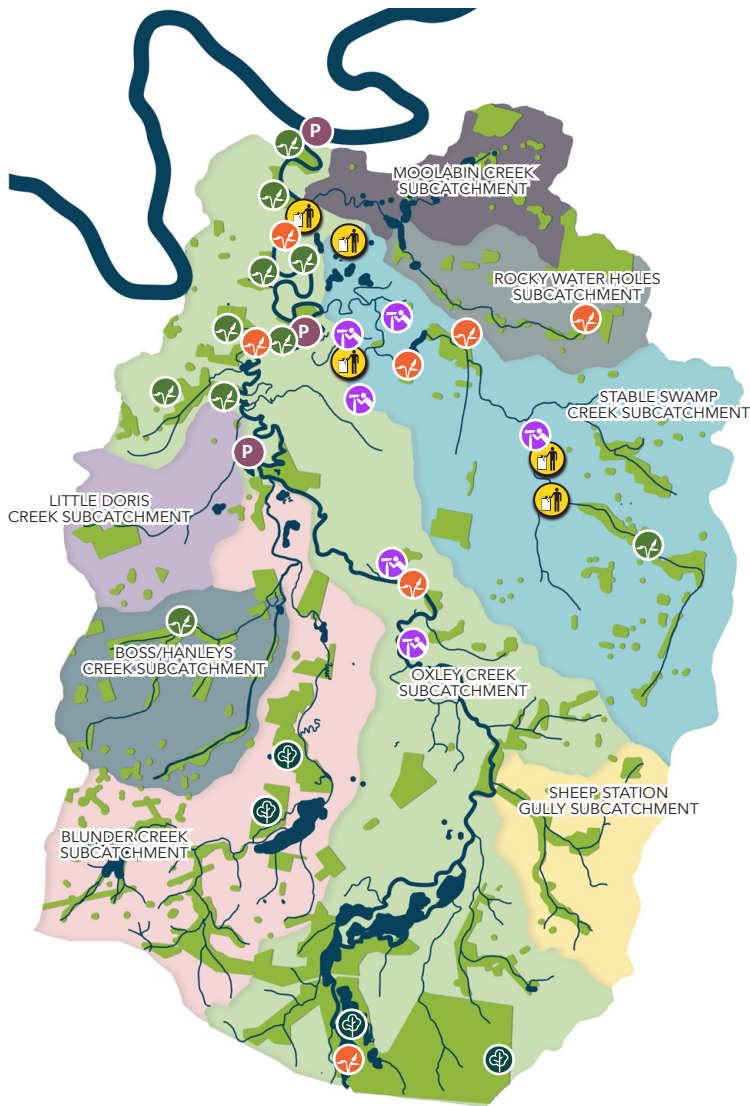
Social value

Current catchment condition: Based on a limited sample size, 5.2% of survey participants have visited Oxley Creek, with 75% having visited Oxley Creek less than once a month.

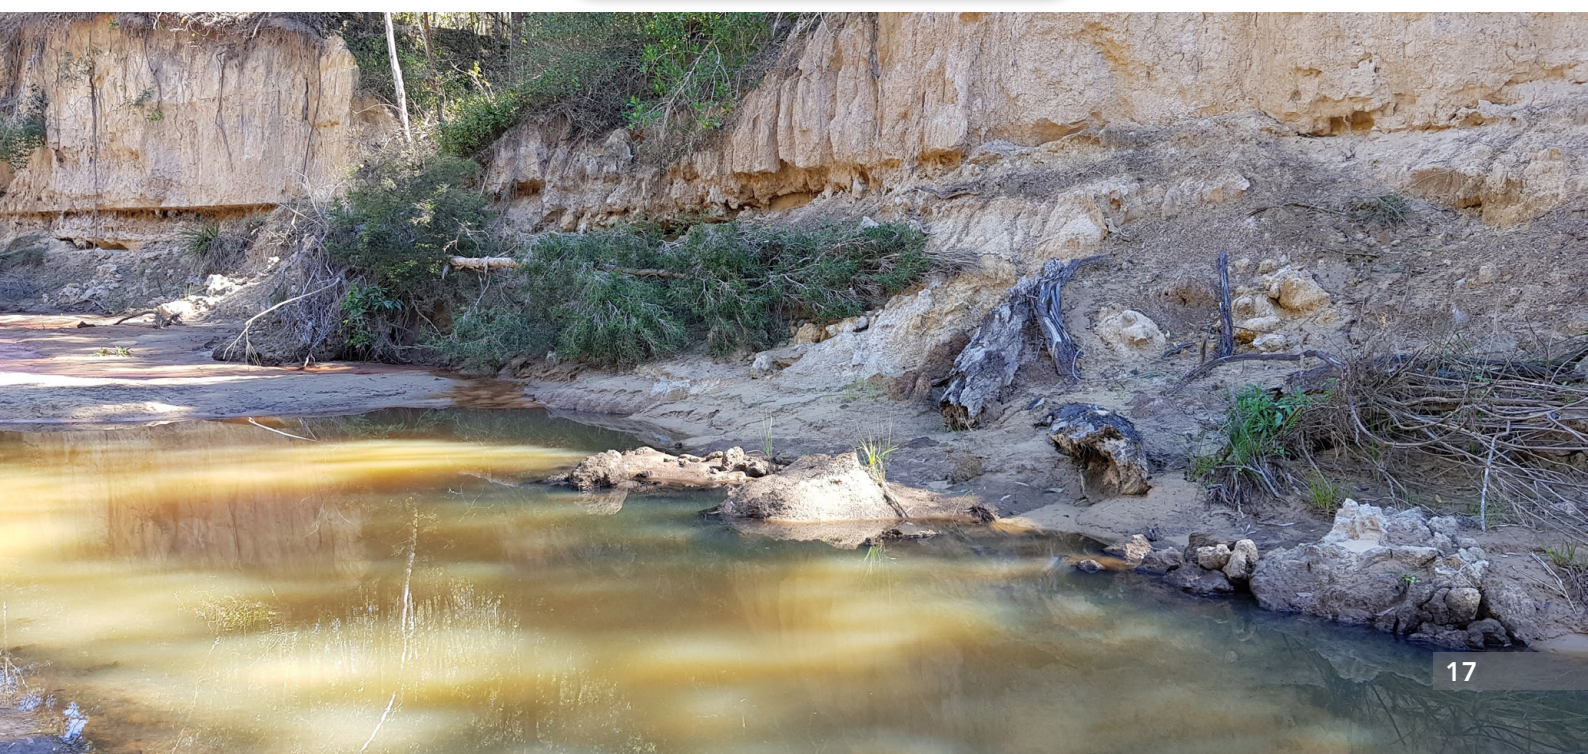
There are two active headcuts within the Oxley Creek corridor, one located upstream of Johnson Road, Larapinta, and the other near Brookbent Road, Pallara. These areas are identified as stretches with characteristics that are highly prone and vulnerable to erosion, which could be caused by catalysts such as flash flooding or loss of vegetation.

Current catchment condition: Multiple sites of extreme erosion along Oxley Creek, with two active headcuts located upstream of Johnson Road, Larapinta and near Brookbent Road, Pallara.

- Floodplain disturbance areas
- Unstable banks from sand extraction
- Active headcut locations
- Dam
- Low channel erosion risk
- Moderate channel erosion risk
- High channel erosion risk
- Very high channel erosion risk
